**TECHNICAL AUDIT
OF THE
COMCAST CABLE SYSTEM
FOR
CARROLL COUNTY, MARYLAND**

February 2008

Prepared by
Columbia Telecommunications Corporation
10613 Concord Street
Kensington, MD 20895
301.933.1488
www.CTCnet.us

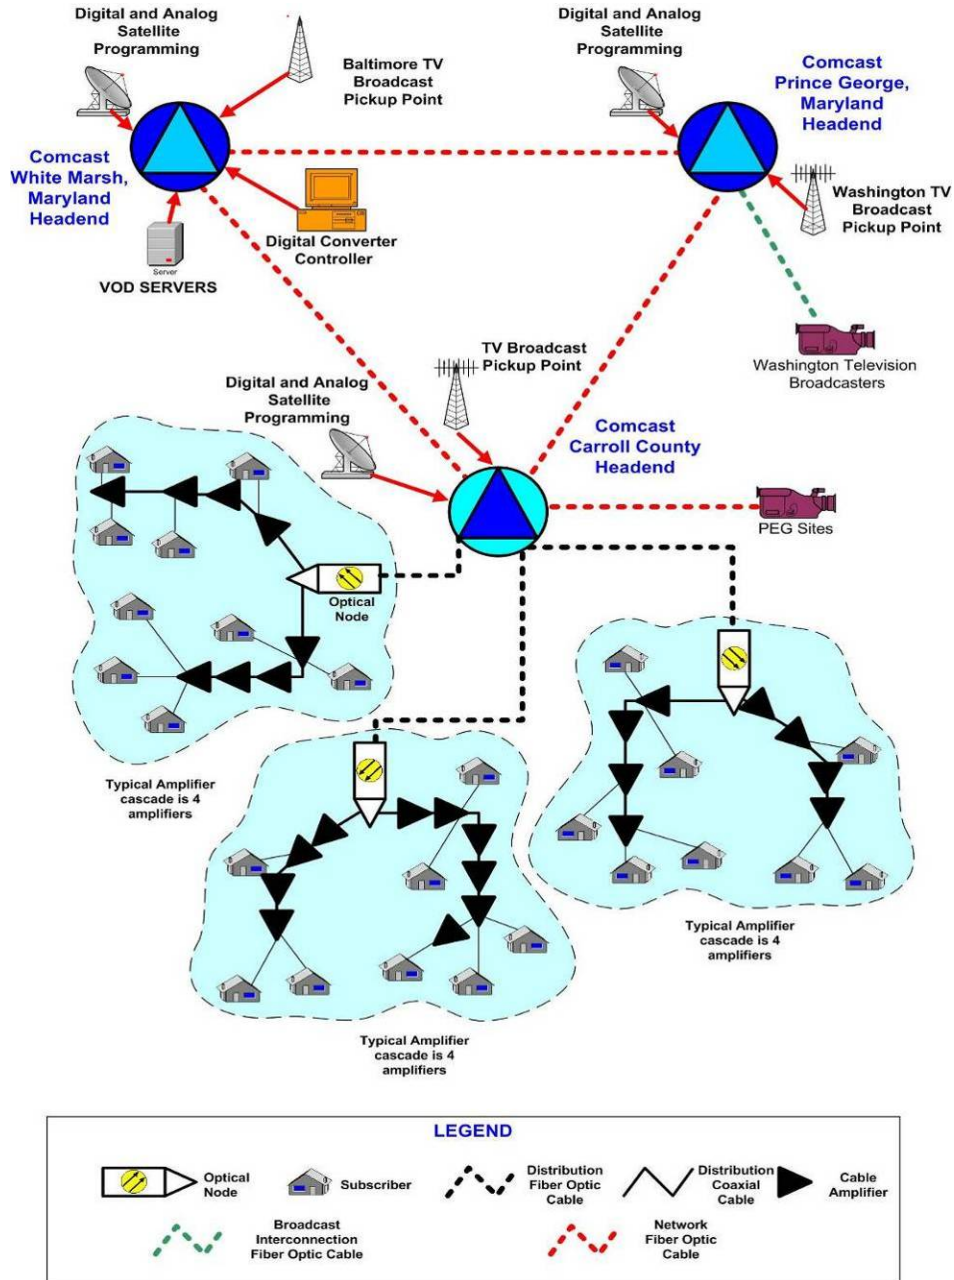
Figure 1: Carroll County Cable System

Local PEG access channels are transported to the Carroll County headend using dedicated fiber optic video transport equipment and are inserted into the channel line-up at the headend. The Carroll County system has five PEG channels assigned on the network. The programming carried on the PEG channels originates at three locations in the County and is transported to the headend through a fiber optic link. At the CMC, Community TV, Town and Community Programming, and the Carroll County Government Channel are produced. The Carroll County Public Schools and the Carroll County Community College produce their own channels. Figure 1 illustrates the Carroll County system architecture.

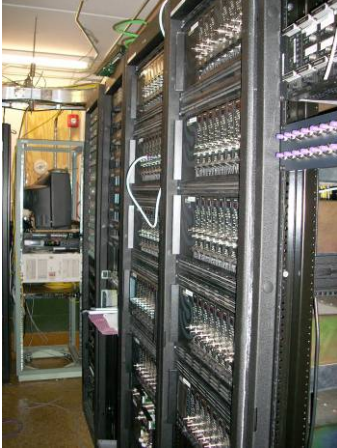
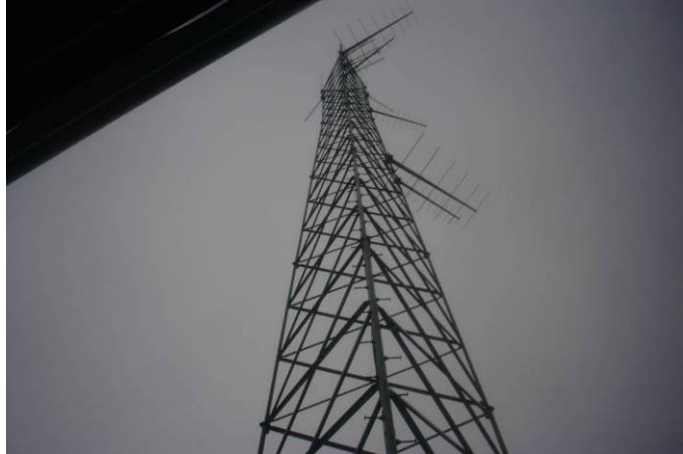
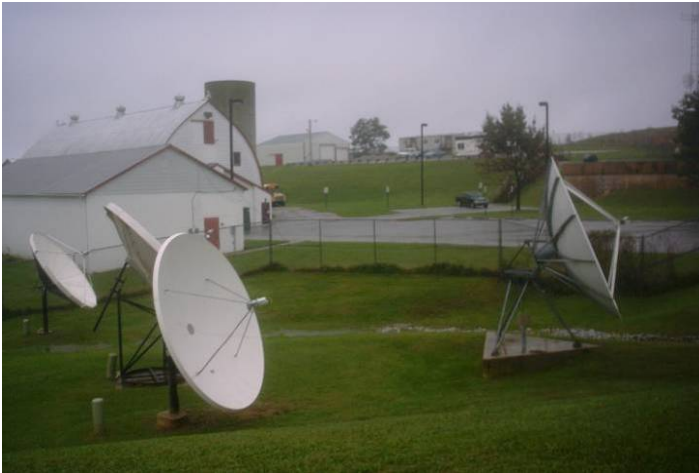
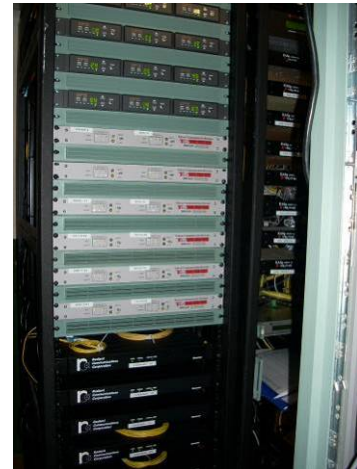
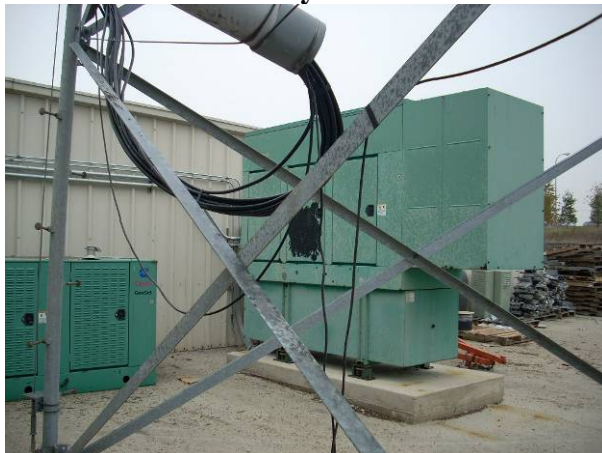
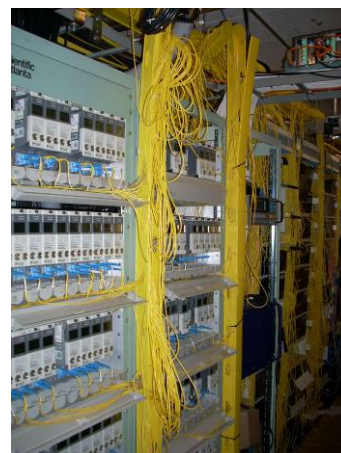
Figure 2: Westminster Headend

The majority of modulators have been replaced with the Stratum series made by Standard Communications. These devices are used to generate the individual channels carried on the cable system. The fiber optic lasers and optical receivers are the older Scientific Atlanta Prisma series, but Comcast is in the process of changing over to the Motorola GX series. Fiber patch panels and combining networks are made by ADC.

Headend equipment is powered by a Liebert battery operated uninterruptible power supply (UPS). A stand-alone Onan back-up generator is in place that automatically goes into operation in the event of failure of the commercial power. The UPS provides power during the transition phase while the generator starts after a commercial power interruption.

Overall, the majority of the headend equipment examined appeared to be in working condition and consistent in age and quality to what we have observed in other modern cable systems. Figure 2 illustrates the headend facility, tower, and satellite antennae.

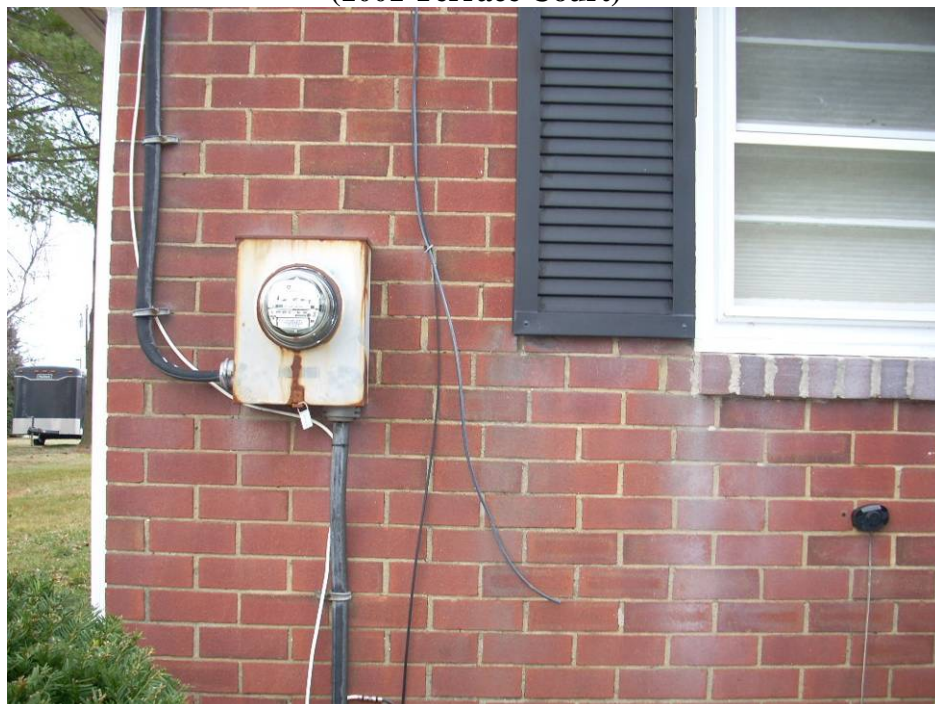
**Figure 3: Disconnected Drop Not Grounded
(1001 Terrace Court)**

We found two disconnected drops that were not grounded.

- Comcast should correct grounding deficiencies in the physical plant and drops. They should conduct an inspection of all plant grounding infractions that may present immediate safety hazards. The specific details of these violations are discussed in Section IV of this report.

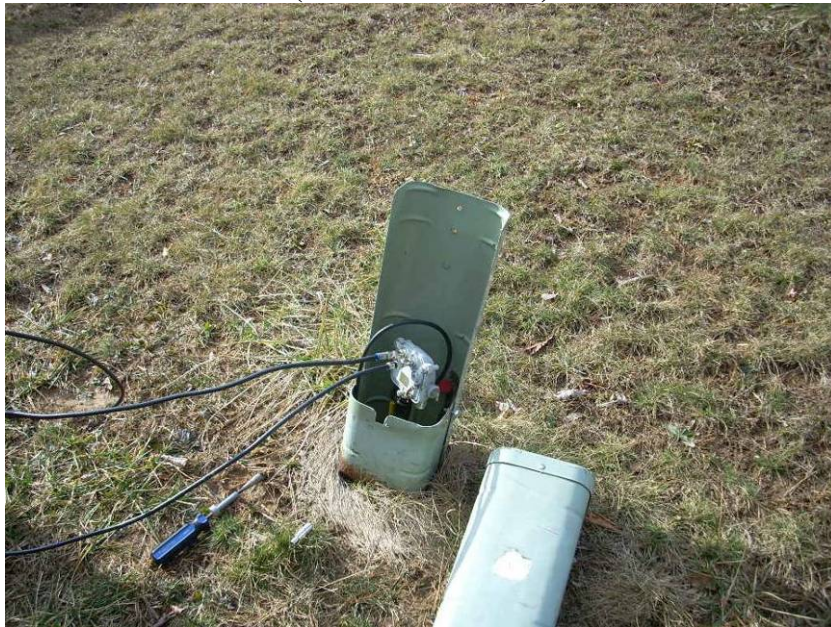
During our inspection we found six end-of-line locations where the system was not properly grounded as required by the NEC or the NESC.

**Figure 4: Underground Plant EOL Not Grounded
(213 Lincoln Lane)**

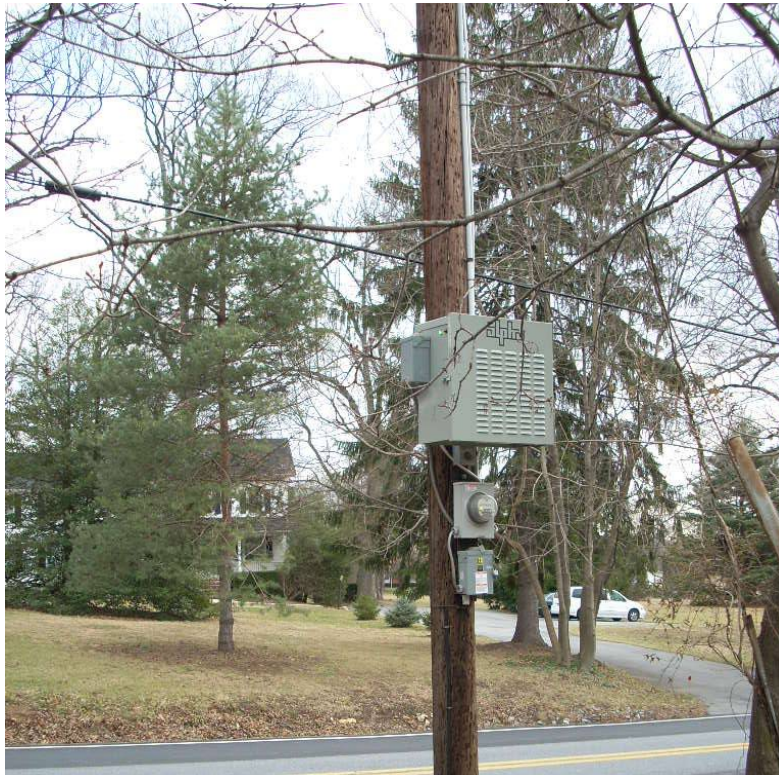
**Figure 5: Complaint Aerial Standby Power Supply
(Blanker Road and SR 32)**

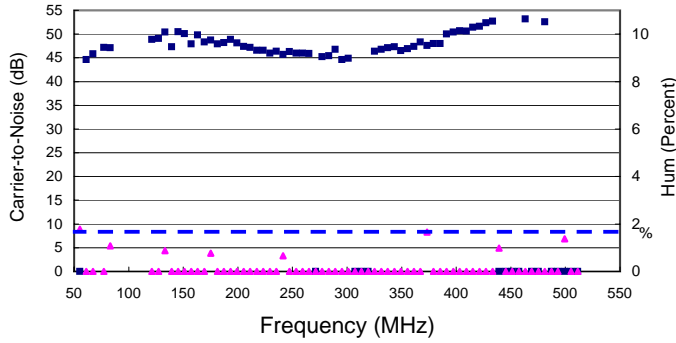
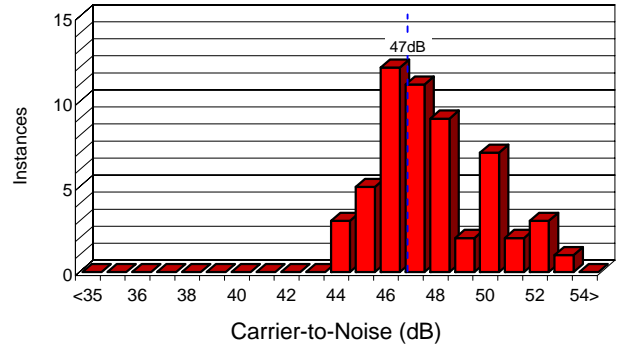
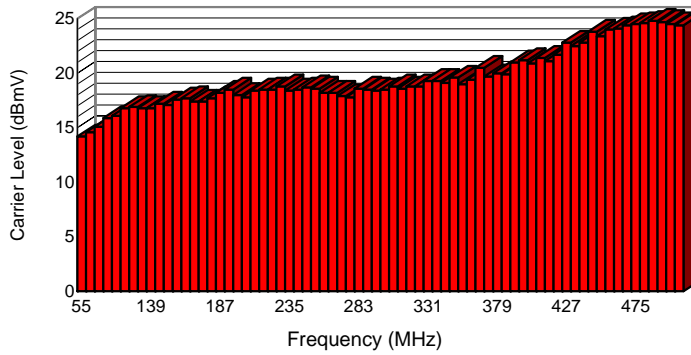
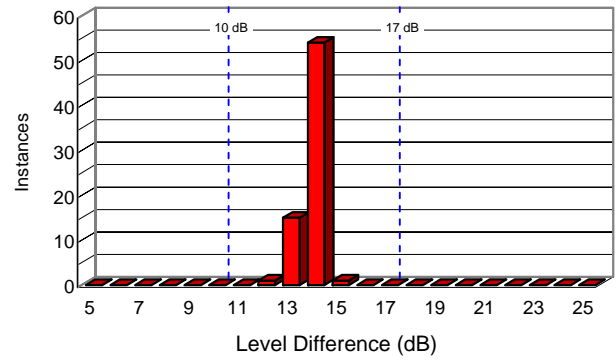
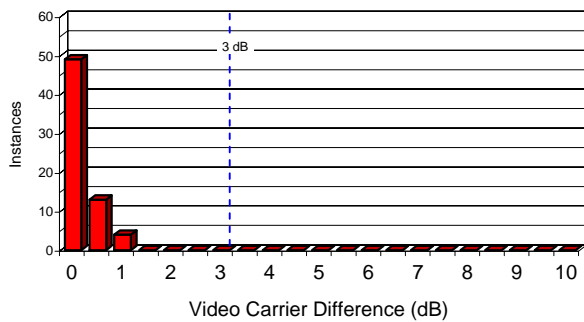
Comcast Headend 11/09/07

Average 48.0 dB Min. allowable 43 dB

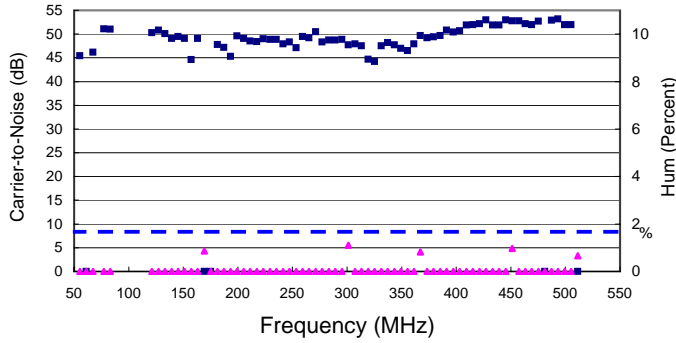
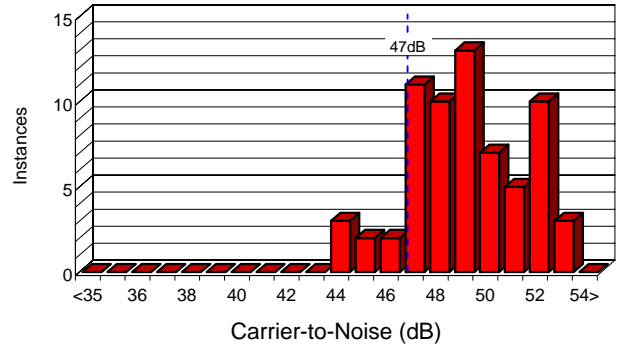
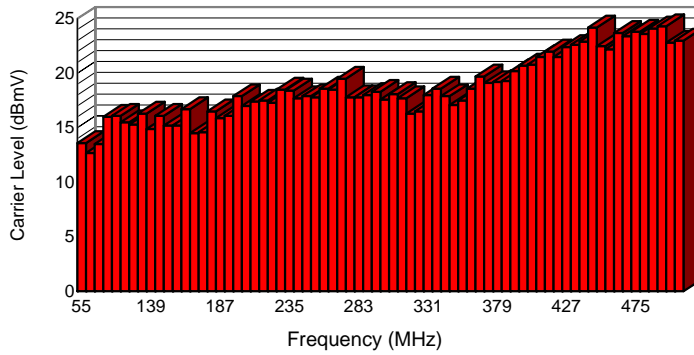
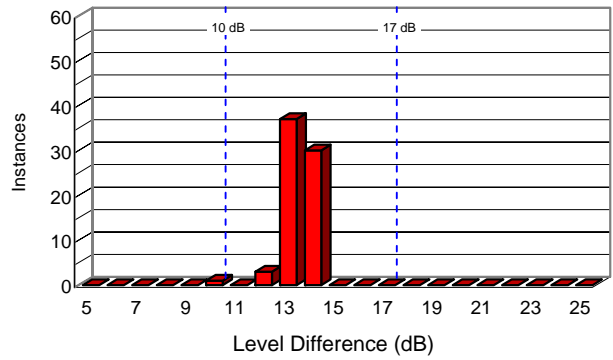
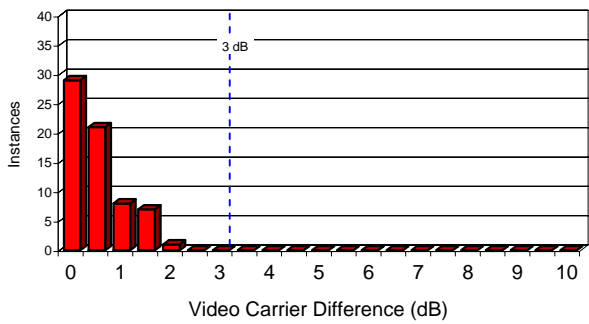
TP1 1327 Washington Road (Headend) 02/07/08

Average	49.4 dB	Min. allowable	43 dB
---------	---------	----------------	-------

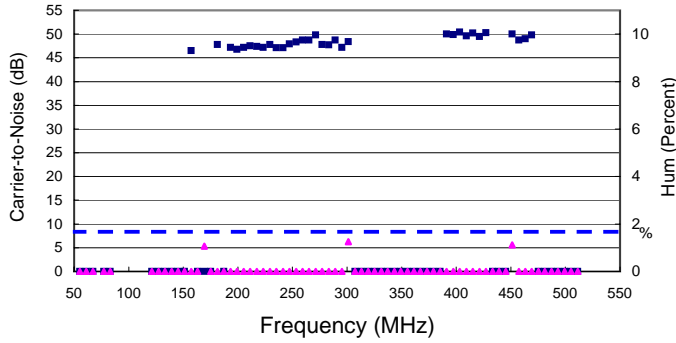
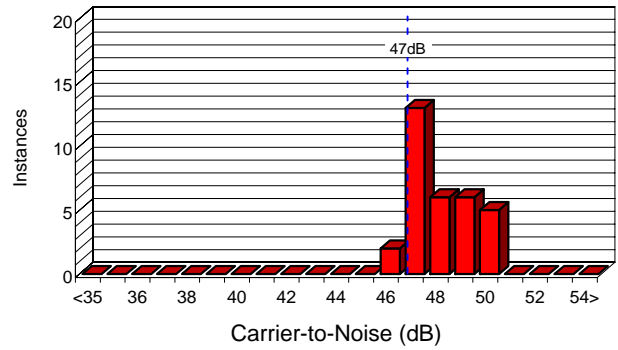
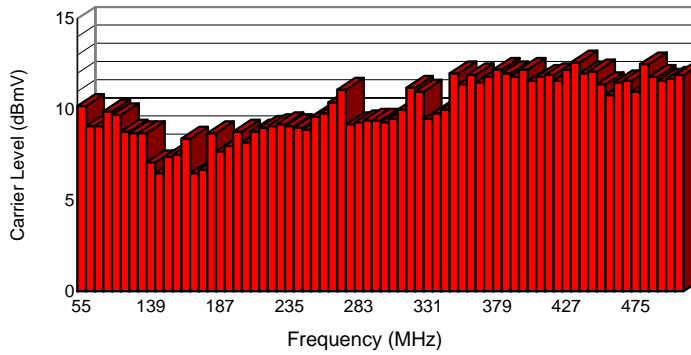
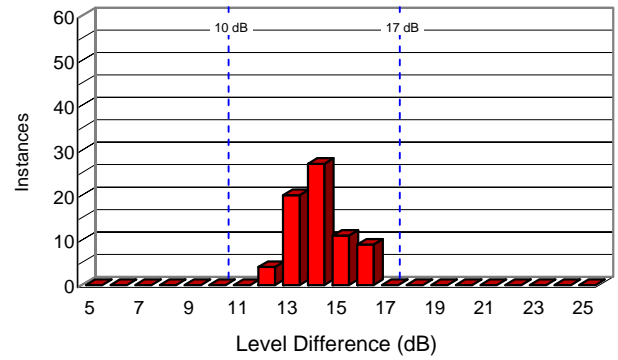
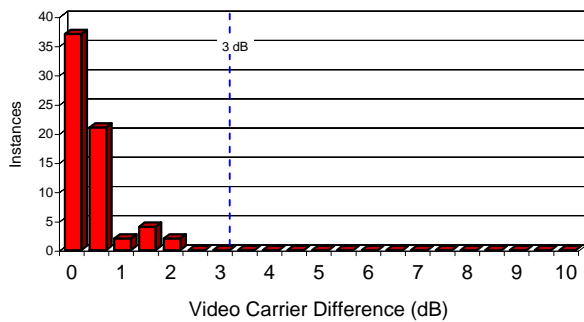
TP2 2325 Pin Oak Drive 02/07/08

Average	48.4 dB	Min. allowable	43 dB
---------	---------	----------------	-------

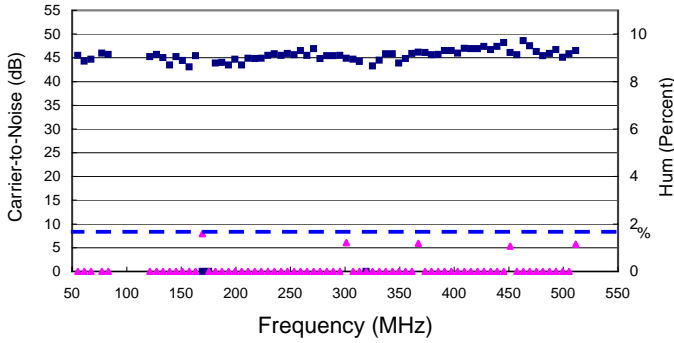
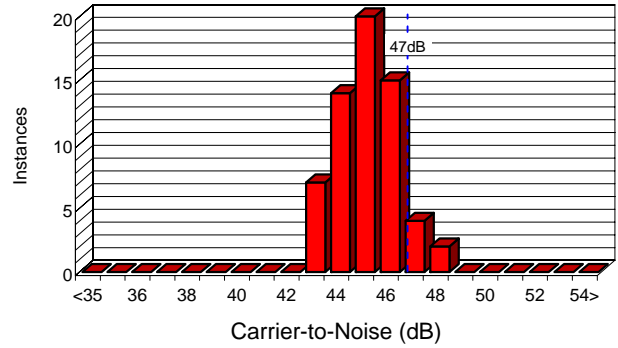
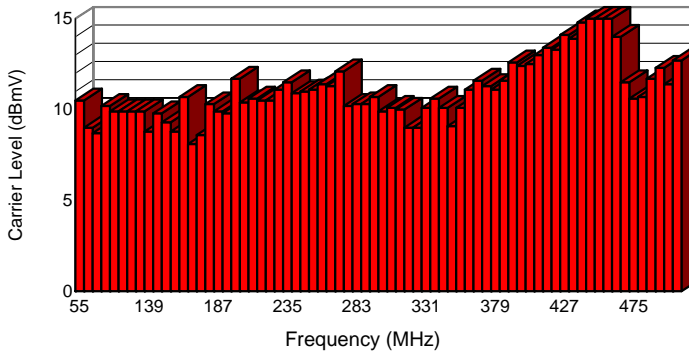
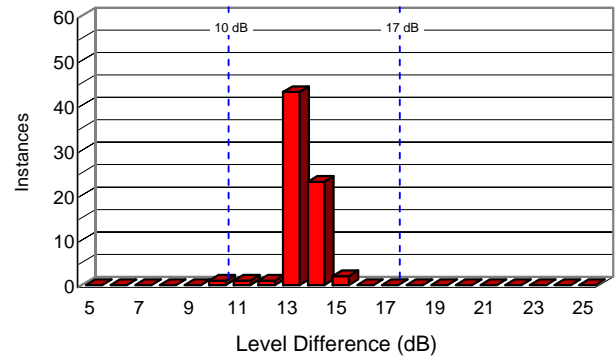
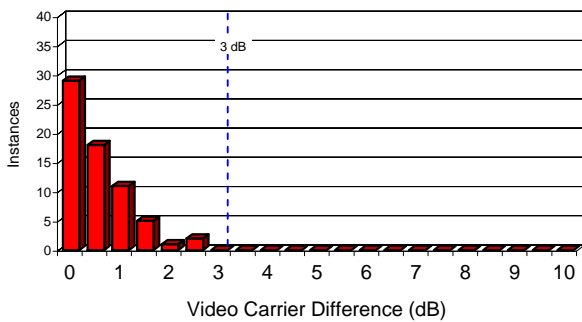
TP3 1001 Terrace Court 02/07/08

Average	45.5 dB	Min. allowable	43 dB
---------	---------	----------------	-------

The carrier-to-noise ratio in a modern cable system is a function of received optical power at the node. Comcast technical staff advised us they were in the process of replacing the older headend lasers which generate the optical power. CTC recommends that Comcast expedite the replacement of lasers and make sure all optical connectors are clean. This should improve C/N ratios to averages of 48 dB as measured at the other test points.

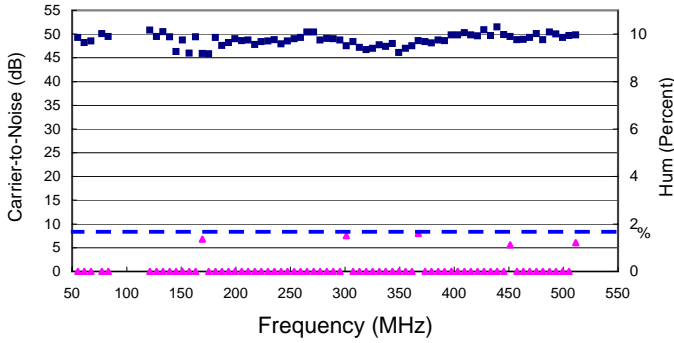
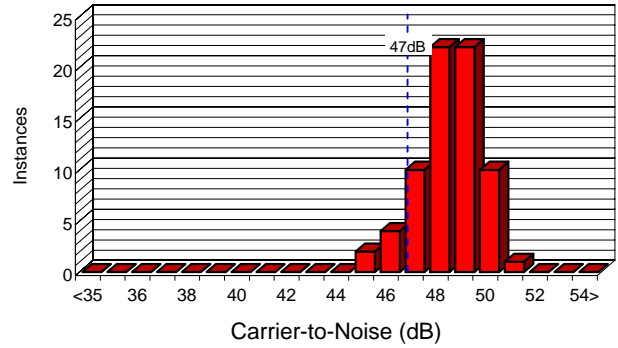
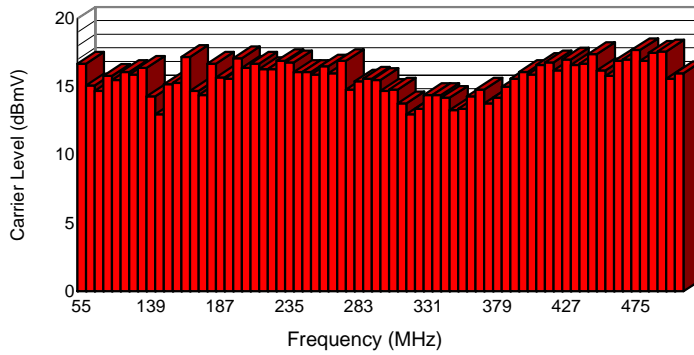
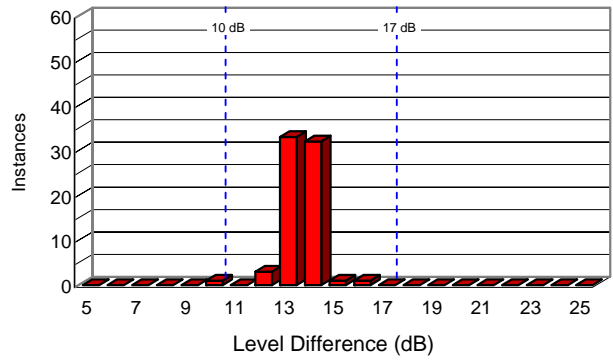
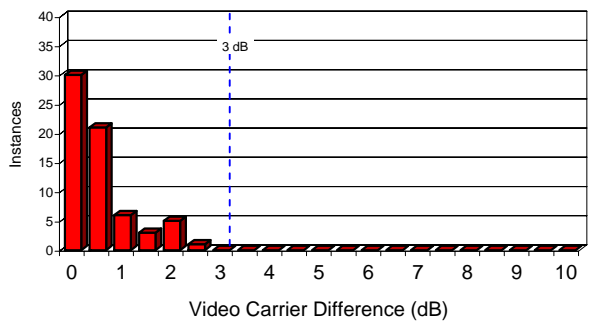
TP4 1627 Exeter Road 02/07/08

Average	48.8 dB	Min. allowable	43 dB
---------	---------	----------------	-------

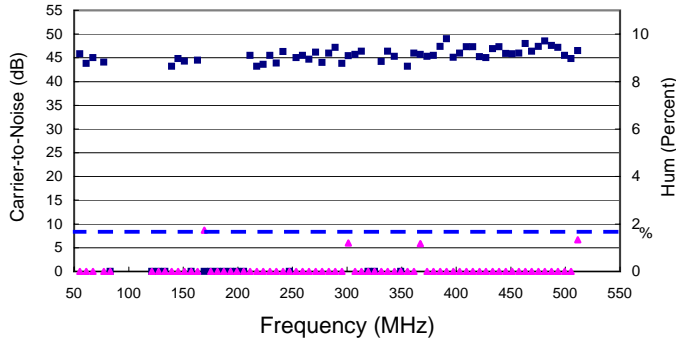
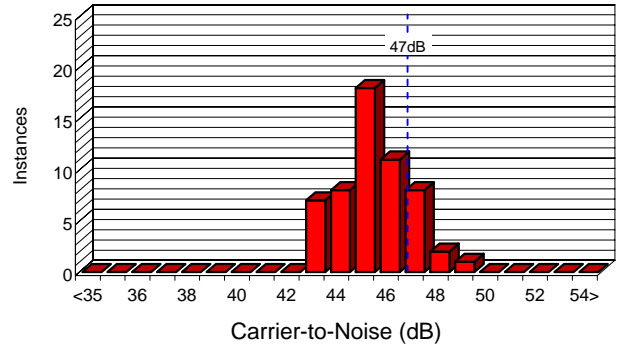
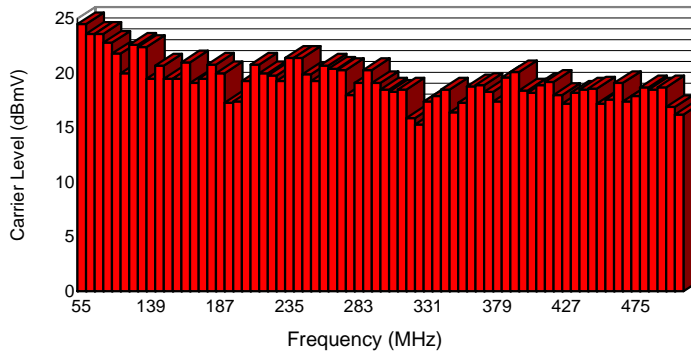
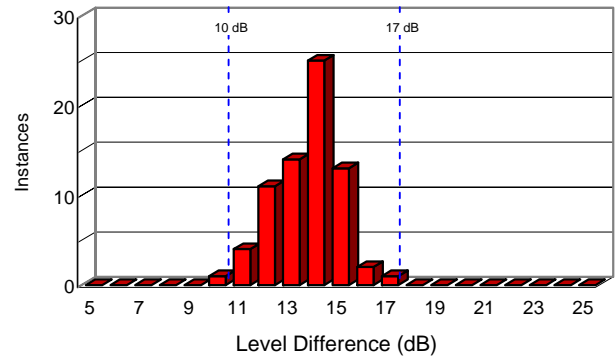
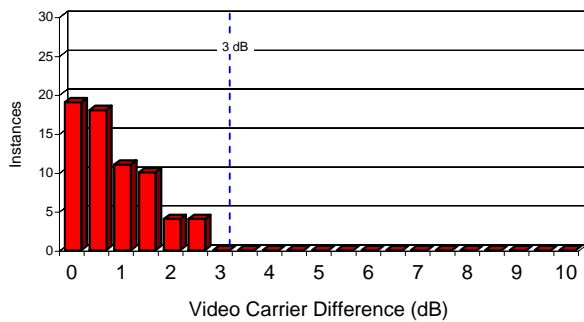
TP5 213 Lincoln Lane 02/07/08

Average	45.6 dB	Min. allowable	43 dB
---------	---------	----------------	-------

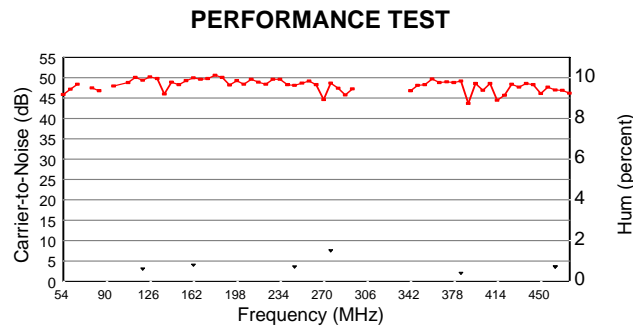
PERFORMANCE TEST GRAPHS

Performance test graphs display carrier-to-noise and hum data collected at each test point as measured by the Wavetek Stealth SDA 4040 signal analyzer (Stealth). The carrier-to-noise readings are plotted on the upper portion of the graph and are required by the FCC to be at least 43 dB. Hum readings on selected channels are plotted near the bottom and referenced to the right-hand scale. Hum is undesired modulation of the television visual carrier by power line frequencies or their harmonics (i.e. 60 or 120 Hz), or other low frequency disturbances. Hum causes decreased picture quality, typically described as horizontal lines that scroll up the screen. Hum measurements are required by the FCC to be less than 3 percent.

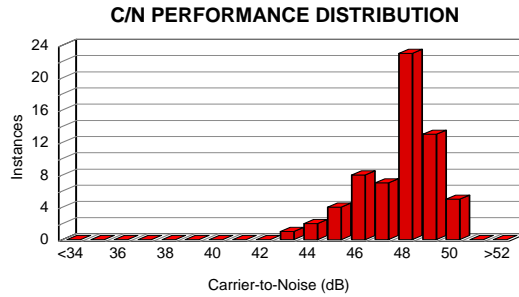
C/N PERFORMANCE DISTRIBUTION GRAPHS

Carrier-to-noise performance distribution graphs show the number of measurements taken (instances) which register each dB level. The carrier-to-noise ratio is required by the FCC to be at least 43 dB.

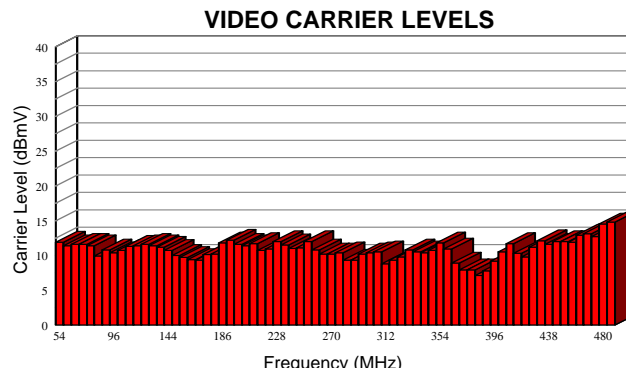
VIDEO CARRIER LEVELS

Each channel's video carrier signal is measured at the test point using a standard 30-meter drop cable. The results of these measurements are plotted on the Video Carrier Level graphs. The carrier level for each channel is indexed by frequency assignment. The FCC requires that each channel must have a video carrier level of at least 0 dBmV.

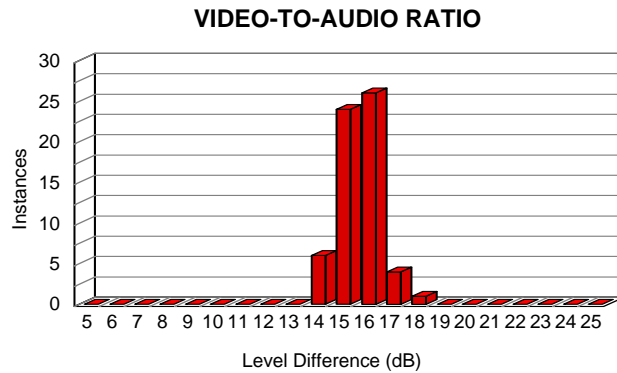
VIDEO-TO-AUDIO CARRIER RATIO

The video-to-audio carrier ratio graphs illustrate the difference, measured in dB, between the video carrier and the audio carrier on the channels. The audio carrier level is required by the FCC to be between 10 and 17 dB below the video carrier level. In the sample below, 26 channels had a difference of 16 dB.

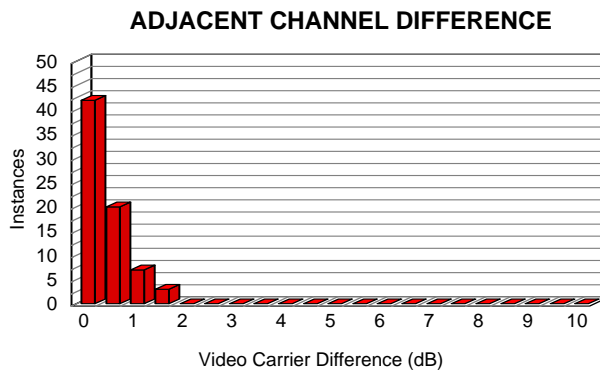
ADJACENT CHANNEL DIFFERENCES

The difference in video carrier measurements from one channel to its adjacent channel is called the adjacent channel difference. The FCC requires there be no greater than a 3 dB difference between the two channels. In the example below, 20 channels had a difference of 0.5 dB.
